CASE HISTORY

Copper Pipe Failure by Microbiologically Influenced Corrosion

Thirty copper water service failures occurred between 1998 and 2003 in the distribution system of the Brown Deer Water Utility (Brown Deer, Wisconsin).

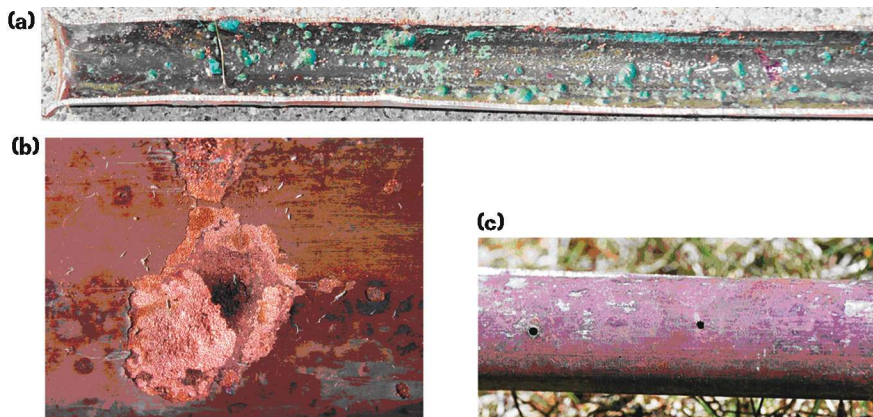
FIGURE 1

Greenish tubercles and areas of greenish film were typically seen on the interiors of the corroded pipes (Figure 1[a]). Similar pipe interiors can be seen in other reports of copper biocorrosion.¹ Pits were

Typical corroded copper water service pipes. (a) Tubercles found on the interior of corroded copper pipes; (b) underneath tubercles, pipe interior patterns of sharp-edged pits; (c) interior pits break through the pipe exterior as pinholes.

found underneath the tubercles. Corroded pipes must be handled very carefully, or the nuances of the pit morphology can be destroyed. For this reason, the corroded pipes were cleaned using a gentle electrolytic cleaning process.² Similar to cathodic protection (CP), the cleaning process applies a direct current using the pipe sample as the cathode in an electrolytic cell. However, the current is much higher than would be used in CP. This causes a large quantity of hydrogen gas to form at the metal surface of the cathode underneath any loose nonmetallic corrosion debris and dirt. The gas lifts debris off the surface of the pipe without destroying the metallic structure of the pits. Figure 1(b) shows an example of the jagged pit morphology with undermined copper flakes typical of the utility's corroded copper pipes. Pits with this jagged morphology have been identified as caused by MIC.³ The pits progress to pinholes when the exterior of the pipe is broken through (Figure 1(c)).

In addition, corroded and non-corroded pipes were sent to the Wisconsin State Lab of Hygiene. There, microbiologists inspected the corrosion debris and interior pipe surfaces for microorganisms. In tests using nucleic material stains and microscopy, no microorganisms were observed on noncorroded pipe samples, while "microbe-laced" biofilms were identified in the pitted areas and debris of the corroded pipes.⁴ It is known that microorganisms overcome the toxicity of copper by binding the copper ions in an excretion called extracellular polysaccharides (EPS).¹ The acidic EPS promotes localized dissolution of copper in the form of pitting.

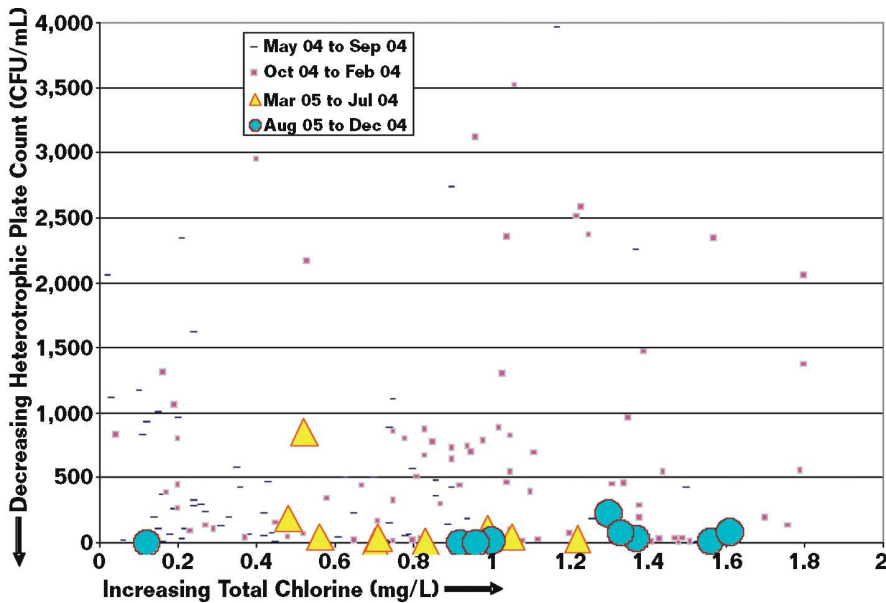
FIGURE 2

Microorganisms and disinfection in Brown Deer, Wisconsin.

To counteract this concentration of nutrients, the technical literature suggests a disinfection dosage of 2.0 to 2.4 mg/L total chlorine when using monochloramine as a disinfectant.^{6,10} The annual average monochloramine disinfection measured throughout the distribution system from 1992 to 2002 was 0.3 to 0.4 mg/L total chlorine. Total chlorine levels in the northern one-third of the system have often been found to be at negligible concentrations. Therefore, it appears that the level of disinfection was inadequate to balance not only the surge of AOC that may have entered the system in 1998 when ozonation was added as a water treatment process, but also remained inadequate after biofilters lowered the AOC to ~100 µg/L.

The HPC values are representative of microorganisms from the adjacent water main. The HPC tests were performed using R2A media, which gives a higher HPC reading than other methods. This method is a useful tool for corrosion investigations as it is more sensitive to the presence of microorganisms. HPC is seen to vary greatly before September 2004. For five months after this point when disinfection was boosted, the variance continued to be seen. By around March 2005, the HPC had decreased greatly. In addition for

This corrosion investigation has been described in more detail elsewhere.¹¹⁻¹³ When MIC was suspected during the investigation, a program of the efficient distribution system cleaning technique called uni-directional flushing was implemented. Following the investigation's recommendations, a disinfection booster station was constructed and placed in operation in September 2004. Improvements have since been seen in the distribution system. Figure 2 shows the measured presence of microorganisms (heterotrophic plate count [HPC] in colony-forming units per mL [CFU/mL]) plotted against total chlorine concentration. These data were obtained at various points throughout the water system in flowing water.

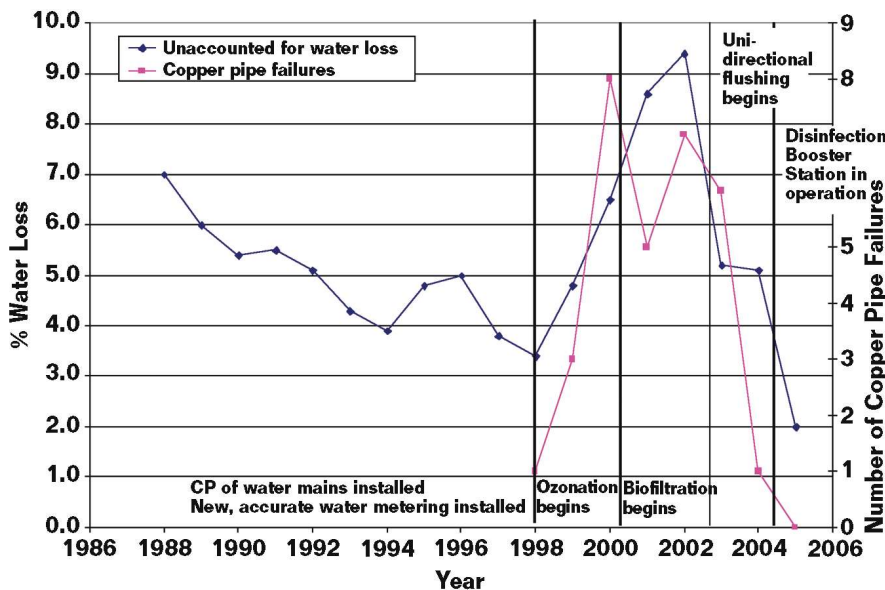
FIGURE 3

Unaccounted-for water loss and copper pipe failures in Brown Deer, Wisconsin.

2005, unaccounted-for water loss dropped to 2% and the number of copper water service line failures dropped to zero. Figure 3 displays the history of water loss and pipe failures in the system.
