FAILURE ANALYSIS

MIC Failure of Type 316L Seawater Pipeline

GEOGY J. ABRAHAM, V. KAIN, AND G.K. DEY,
Bhabha Atomic Research Centre, Mumbai, India

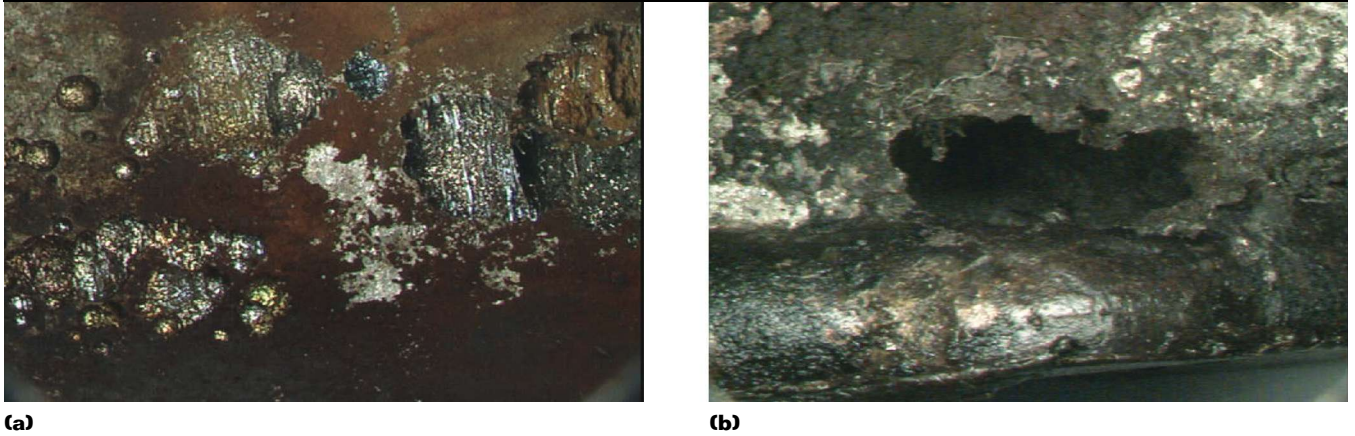
FIGURE 1

The visual examination revealed penetrations and shallow pits on the inside diameter (ID) of the pipe at the weldment, heat-affected zone (HAZ), and base material. Leaky regions were confined to the bottom section from the five to seven o'clock position. The regions on the inner tube side where pitting was observed showed reddish deposits (Figure 1). The transverse section of the pipe also showed pits (Figure 2).

Pits near (a) and away (b) from the weld on the internal diameter surface of Type 316L SS tube (original magnification 175X).

The failure of this Type 316L SS is a classic case of microbiologically influenced corrosion (MIC). The visual examination of the pipe revealed pits that have an aspect ratio <1 . The pits are shallow and have propagated in the transverse direction. The pit morphology gives a clear indication of MIC attack.

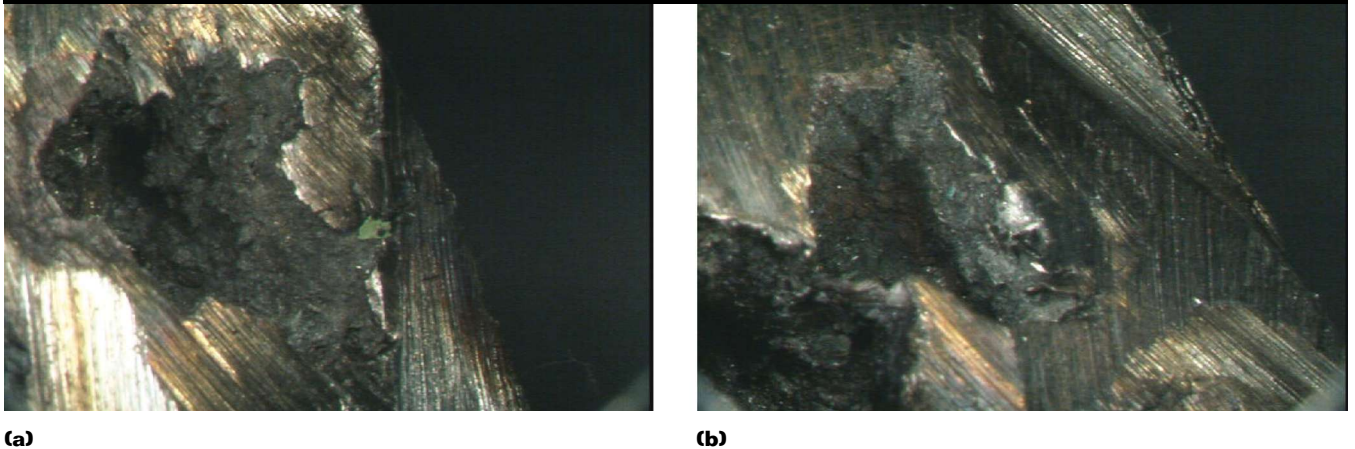
FIGURE 2

Pits (a) and (b) along the cross section of the pipe (original magnification 175X).

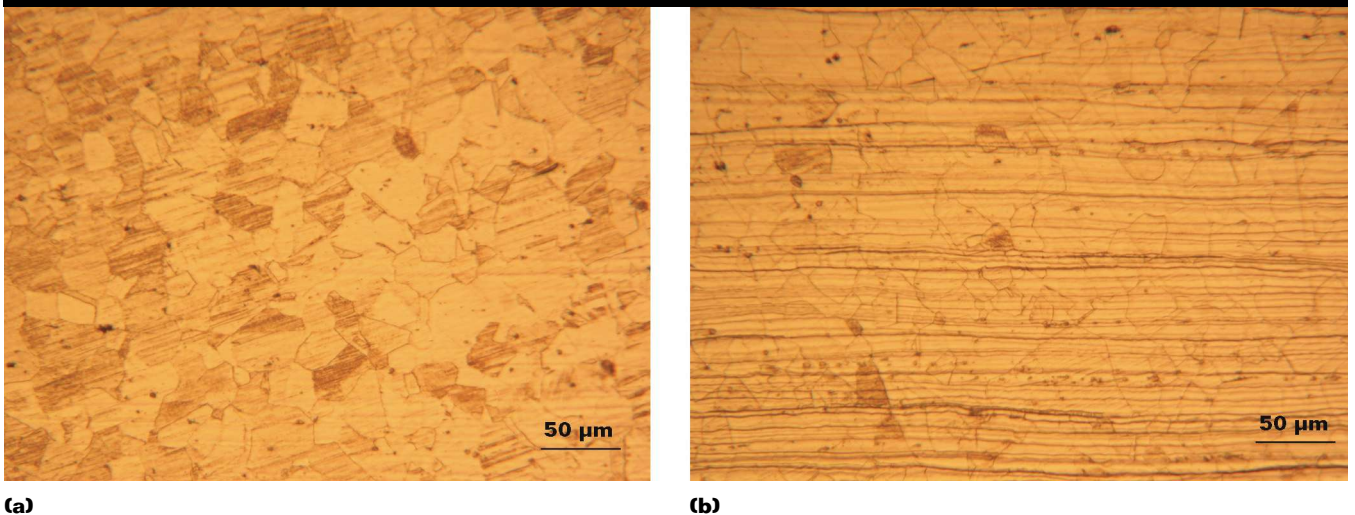
FIGURE 3

Annealed microstructure of Type 316L SS tube: (a) no manganese sulfide (MnS) stringers, (b) presence of MnS stringers.

The sample for metallography was cut from the pipe, polished to a mirror finish, and electrolytically etched to reveal the microstructure. Figure 3(a) shows annealed, step-type microstructure with

negligible stringers present, while in Figure 3(b) there is presence of stringers aligned along the deformation band. Figure 4(a) shows the pit morphology, and Figure 4(b) shows where the secondary pit has initiated from the bottom surface of the primary pit.

The presence of sulfide stringers would be the favorable sites for the initiation of pitting attack. Ryan, et al.³ have demonstrated that pitting was likely to be initiated around the sulfide stringers in SS.

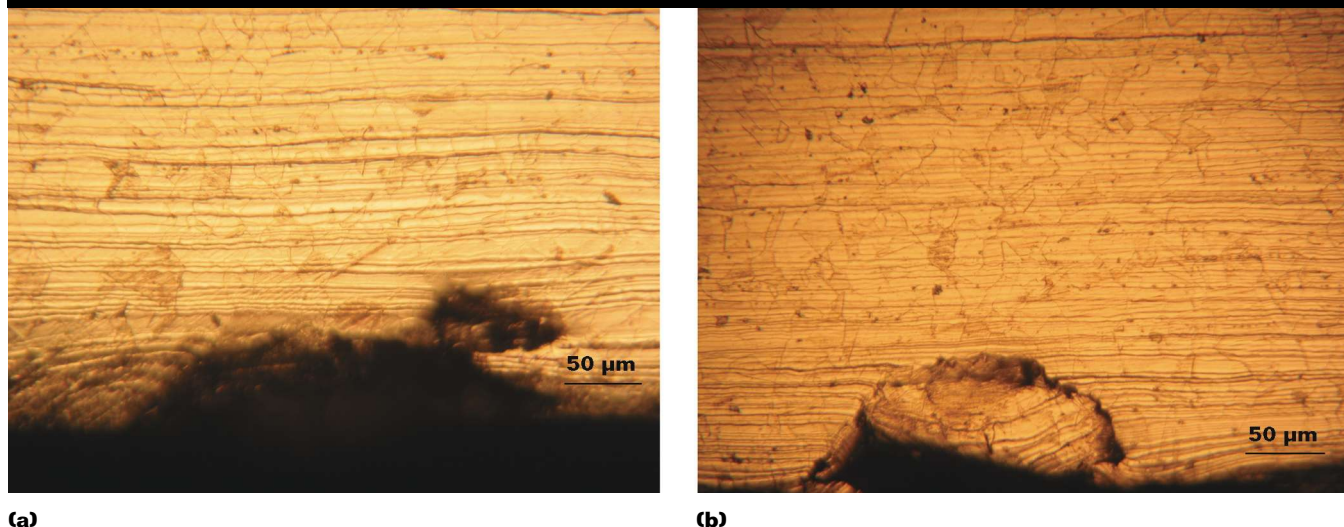
FIGURE 4

Pitted region of the Type 316L SS tube (a) main pit with satellite, (b) scooping of material.

Microbial analysis indicated the presence of SRB and manganese-, iron-, and chromium-oxidizing bacteria. The presence of manganese-oxidizing bacteria could have led to the ennoblement of the Type 316LSS, as reported in literature.⁴⁻⁵ Once a pit (primary) has been formed, the bacterial activity would become localized within the pit and soon would cover itself

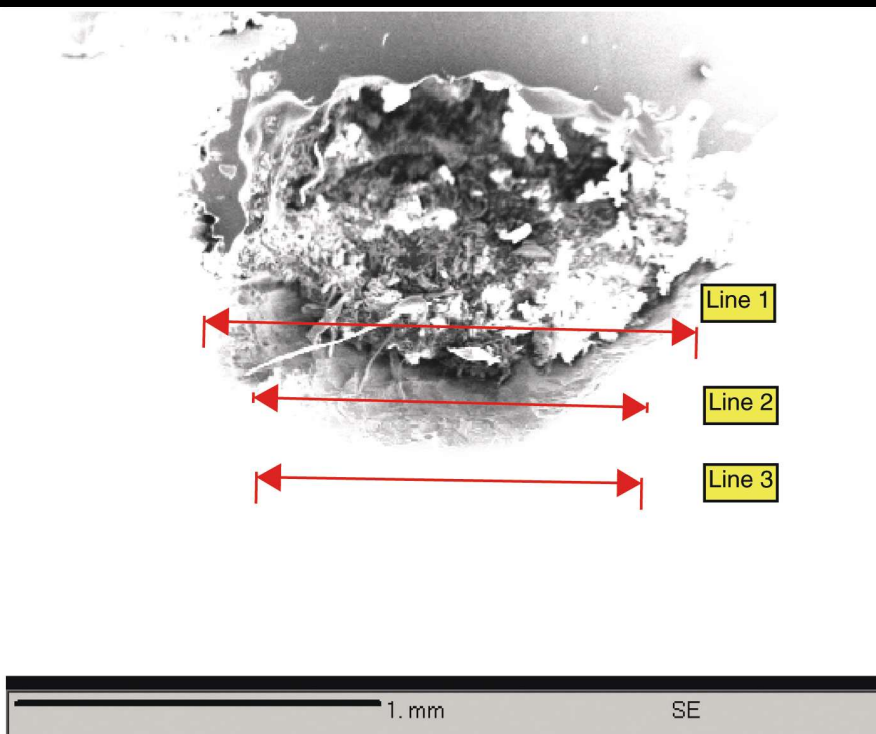
FIGURE 5

Pitted region across which EPMA scanning (Lines 1, 2, and 3) was done.

EPMA was completed on the cross section of the pitted tube region and scanning was done at three different regions near the pit, designated as Line 1, Line 2, and Line 3 (Figure 5).

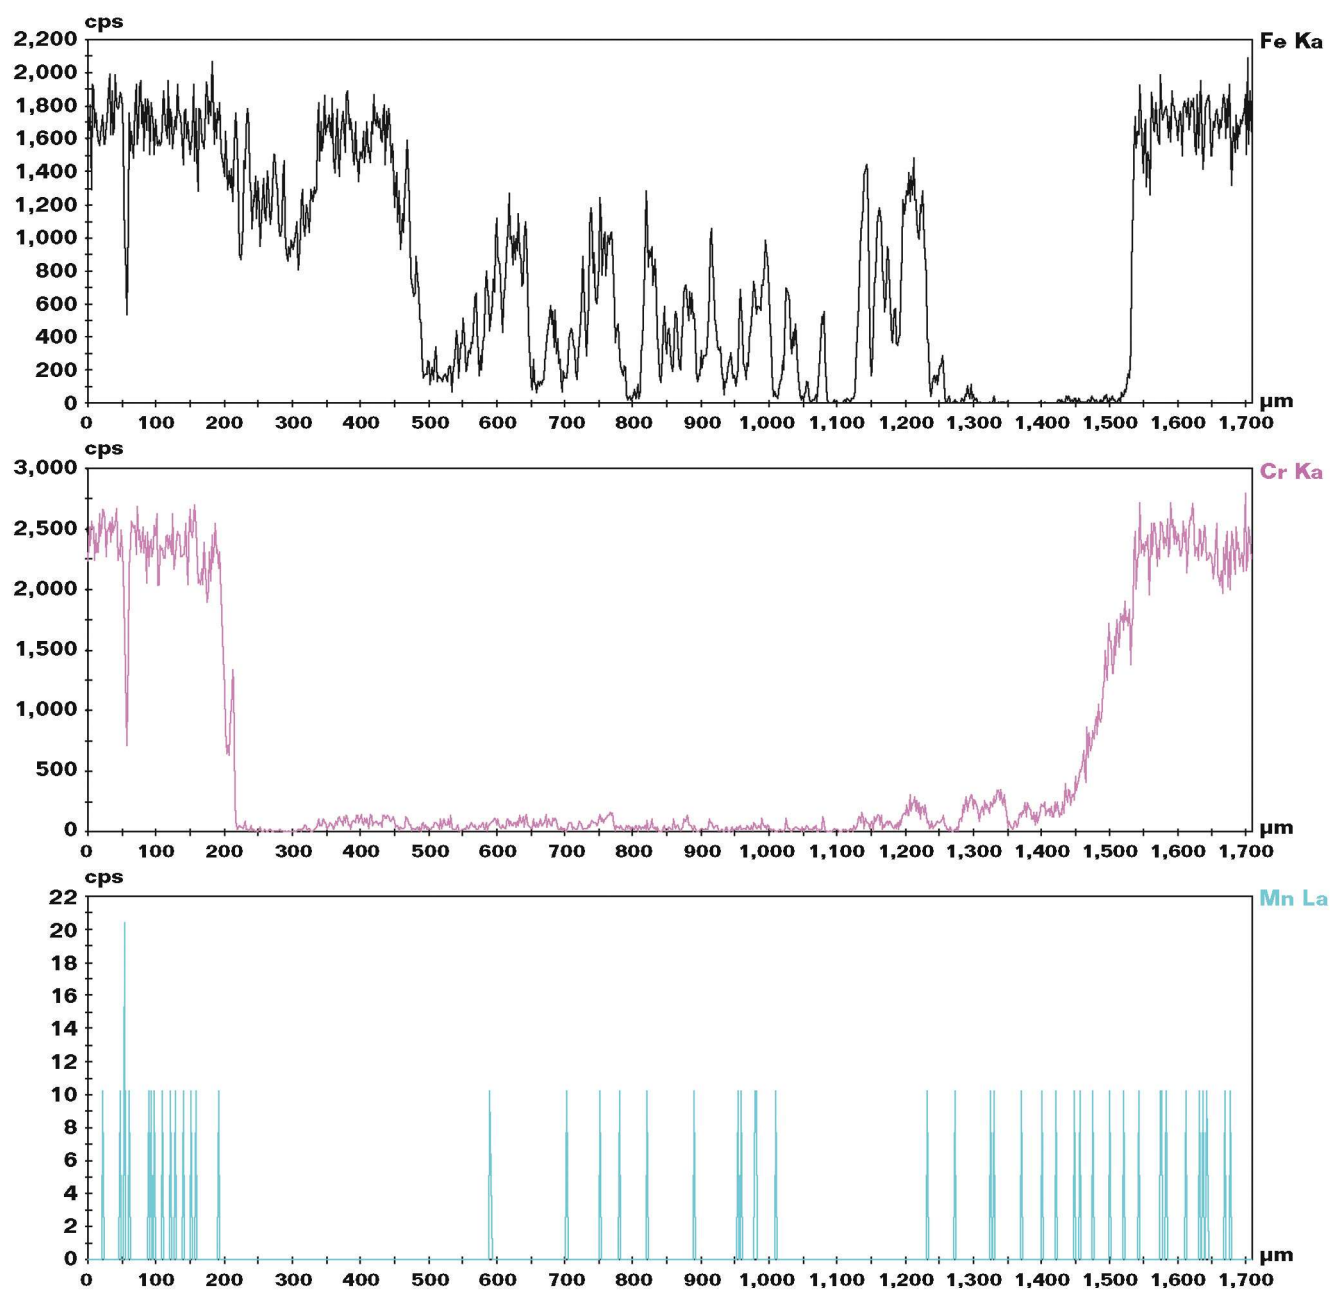
FIGURE 6

Figure 6 shows the iron, chromium, and manganese intensity profile along Line 1, which scans across the pit. The profiles indicate a decrease in chromium concentration within the pit and in the iron concentration near the pit periphery. Line 2 exhibited a similar decrease of chromium concentration within the pit and a decrease in iron near the edge of the pit. Line 3 is in the bulk material, and no such depletion of chromium or iron is seen (Figure 7). The manganese intensity profile taken for all of the three scans shows only background peaks as the concentration of manganese is below the detectable limit.

Intensity profile for iron, chromium, and manganese along Line 1 shows the depletion of chromium and iron.

with biofilm. The SRB would be active when an anaerobic condition sets in during pit propagation. The bacteria are likely to thrive within the pit cavity and produce an acidic chloride environment. Once this process has initiated, kinetics of pitting attack would accelerate autocatalytically and lead to very fast propagation. EPMA results indicate the depletion

of chromium in the pitted region and depletion of iron along the periphery of the pit. X. Shi, et al.⁶ have studied the chemistry of pits generated electrochemically as well as by microbes. The results obtained are very similar to our EPMA results for the microbial induced pits in the failed Type 316L SS pipes. Decrease of chromium content on the surface led

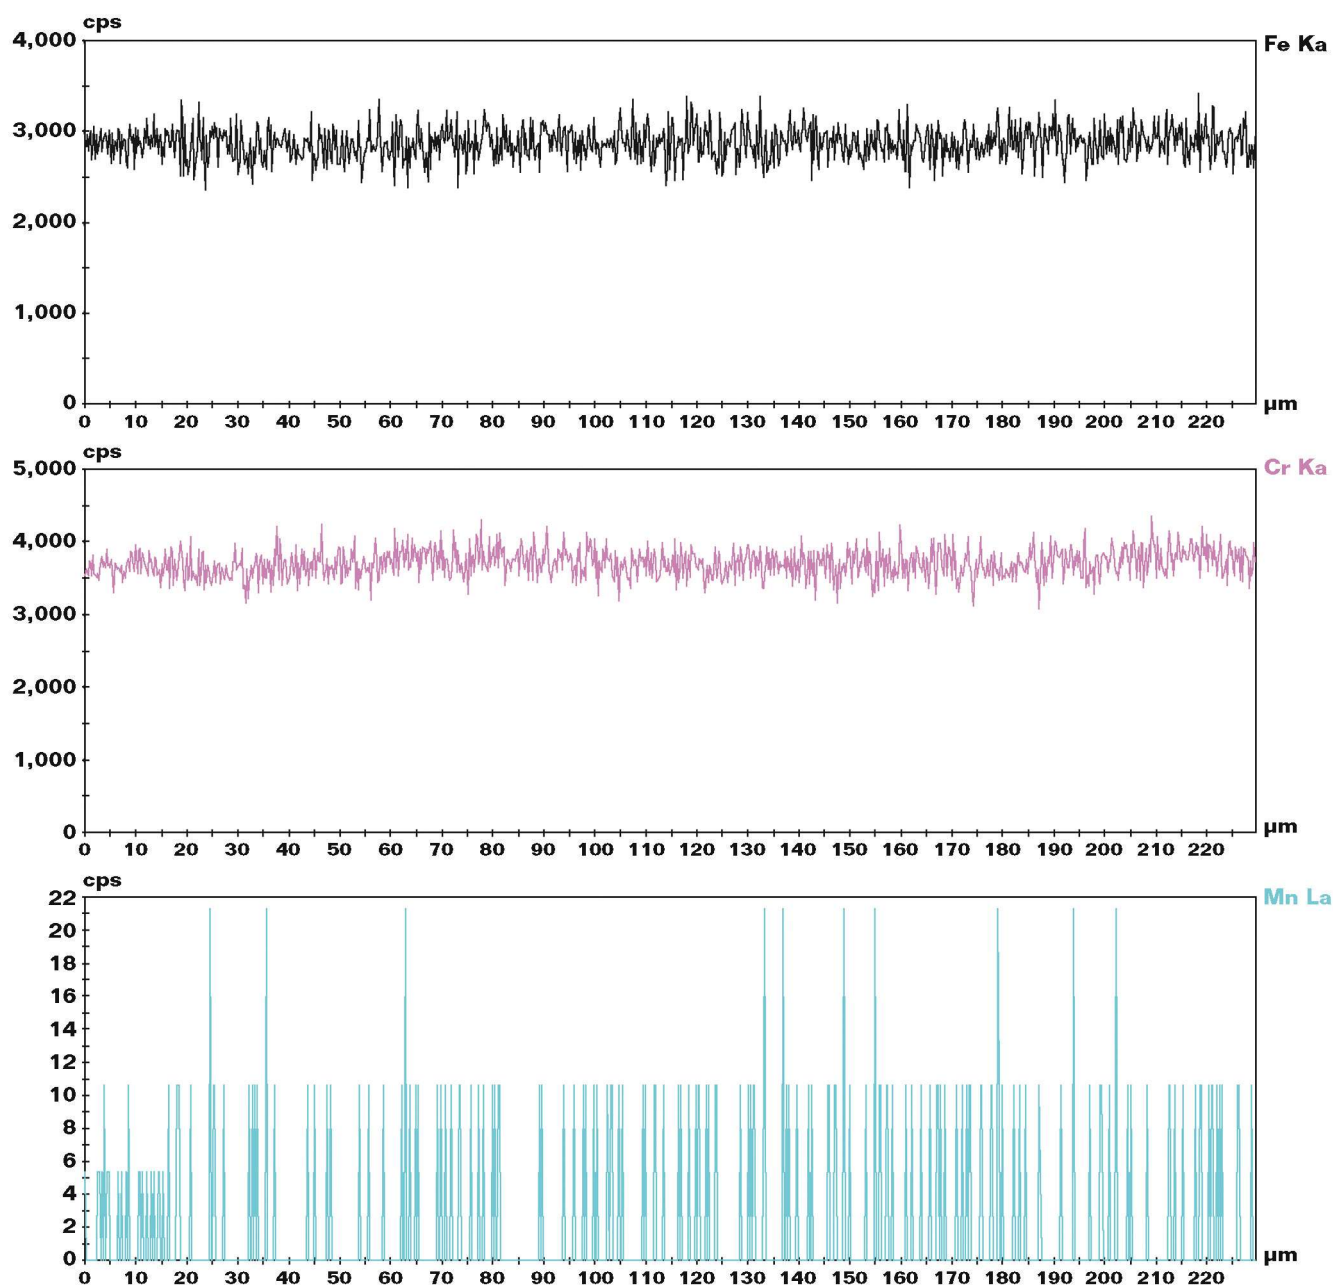
FIGURE 7

Intensity profile for iron, chromium, and manganese along Line 3 (scanning across bulk material) shows no depletion of chromium and iron.
