CASE HISTORY

# Pipeline Restoration at a Generating Station Using Chemical Grout

C. KARL SAUEREISEN, Vice President, Sauereisen, Inc., Pittsburgh, Pennsylvania

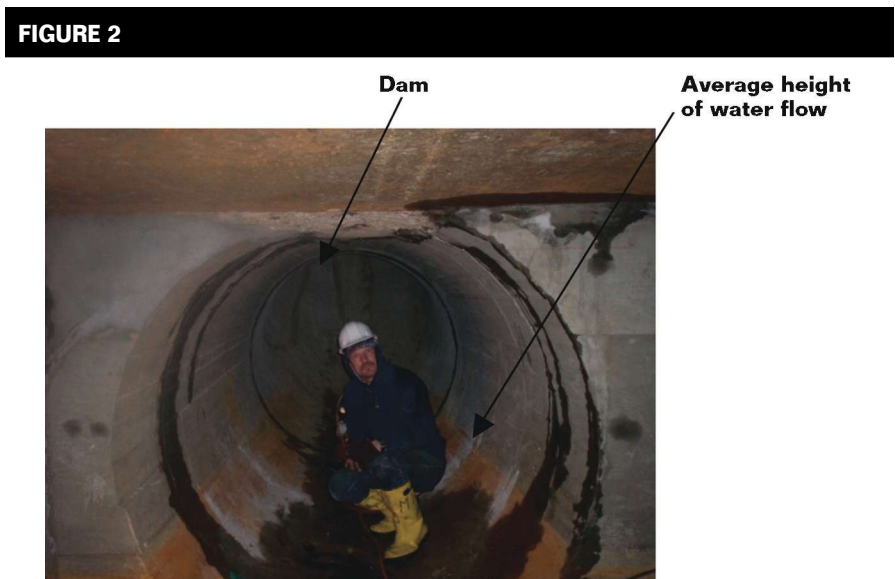
FIGURE 2 The interior of the 40-in water delivery pipe at the intake cistern, just downstream of the dam installed to shut off the water flow.

After temporarily damming the pipe to shut off the water flow (Figure 2), workers went through the interior of the pipe and identified primary rupture and crack locations (Figure 3). They then drilled 1 1/2-in (38-mm) injection ports alongside any identifiable crack or rupture (Figure 4). These ports would be the entry points for placing the grout from within the pipe. Mixing and pumping of the grout proceeded rapidly since even atmospheric moisture can cause the grout to

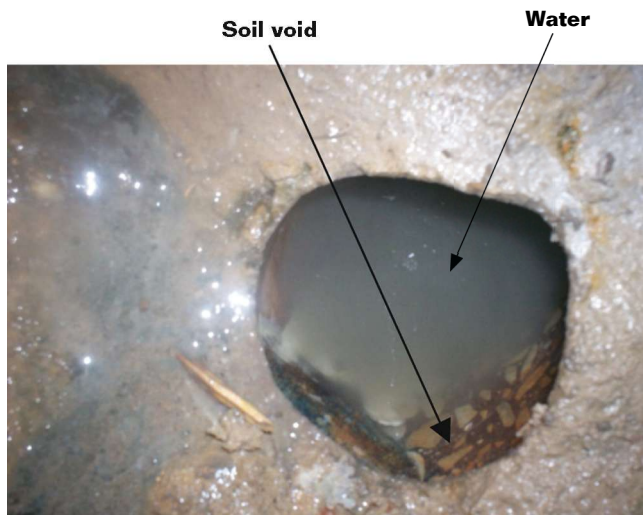
FIGURE 3

Looking down on a core cut in the bottom of the pipe, showing soil void nearly filled with water.

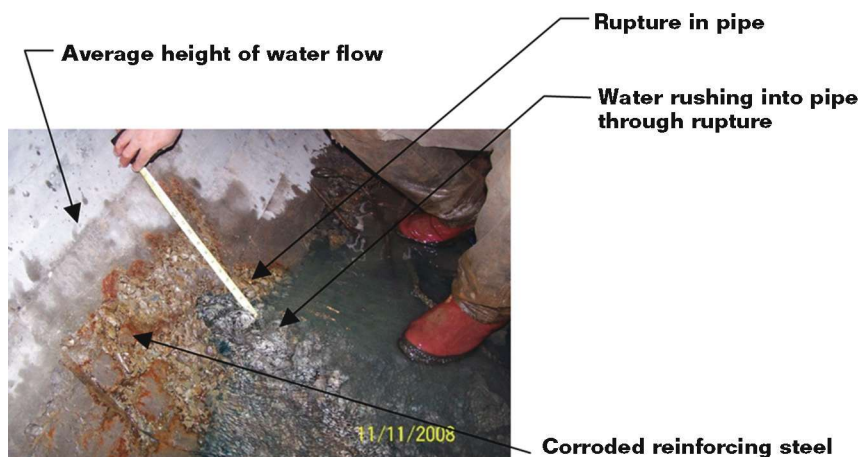
FIGURE 4

Typical conditions within pipe.
