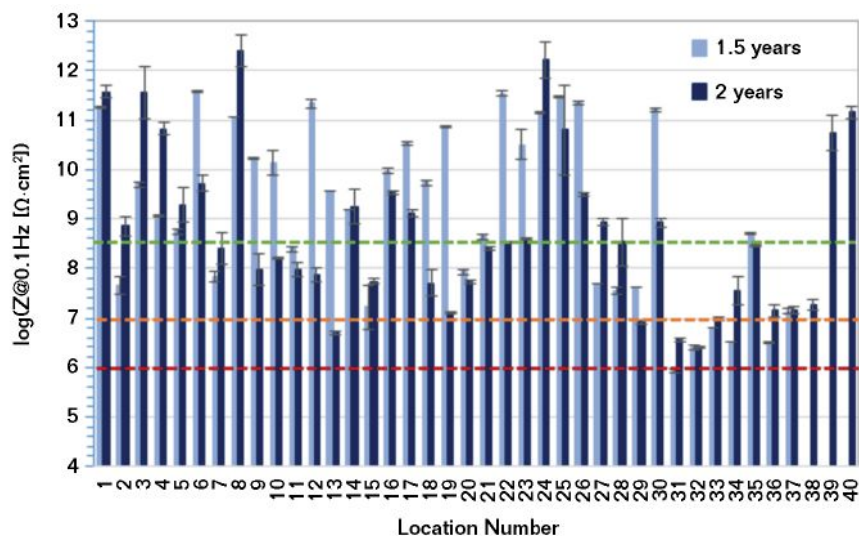
Of the 31 measurement locations (no. 1 to 31) tested in the first run, 21 were found to be well performing. Nine underperforming locations had $\log Z > 7$ and only one underperforming location (no. 31), found in a preload tank, had a $\log Z \approx 6$ and was classified as doubtful. After a further six measurements were taken in the same tank (no. 32-37), one location was classified as well performing (no. 35), one as underperforming (no. 37), and four as doubtful (no. 32, 33, 34, and 36).

The conclusions after the second run may be summarized as follows. Of 31 measurement locations from the first run, 15 locations were found well performing in both runs. Four locations were found underperforming in both runs. Five locations shifted between well performing and underperforming in each direction. Tank location no. 31 remained doubtful in the second run. Another doubtful location was found on the deck of the jacking system (no. 13), but the site was not investigated further. At an additional six tank locations the three previously doubtful locations were found to be underperforming. One additional location measured inside the tank in the second run was found underperforming (no. 38) and the two additional locations measured at sites other than the tank have shown to be well performing (no. 39 and 40).

FIGURE 4 Log Z measured at different locations on the platform 1.5 and 2 years after renewal. Error bars denote the RMS of five consecutive measurements.

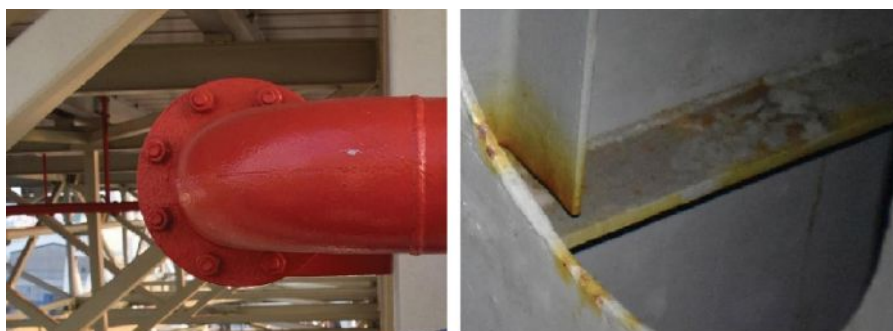
Figure 5 shows the typical appearance of the $\log Z \geq 7$ coatings (left) and the doubtful coating within the tank (right) after two years of atmospheric exposure. It has been discussed previously that low impedance coatings are more likely to exhibit visible early degradation at edges and welds.² Subsequent analysis of the coating specifications revealed that the tanks were the only site where a two-layer self-priming epoxy coating system of 2 by 150 μm , without a need for stripe coating, had been specified and applied.

FIGURE 5 Appearance of the $\log Z > 7$ coatings (left) and of the doubtful coating within the tank (right), after two years of exposure.

ferences were successfully managed by the EIS signal amplitude optimization. Similar conclusions from the two independent runs unequivocally indicated the preload tank as a location of limited coating durability. The rationale for this observation was later found in the specification of the tank coating system. Laboratory and field QCQ testing based on EIS and subsequent statistical analysis have shown the potential to serve as a valuable tool for predictive coating maintenance.
