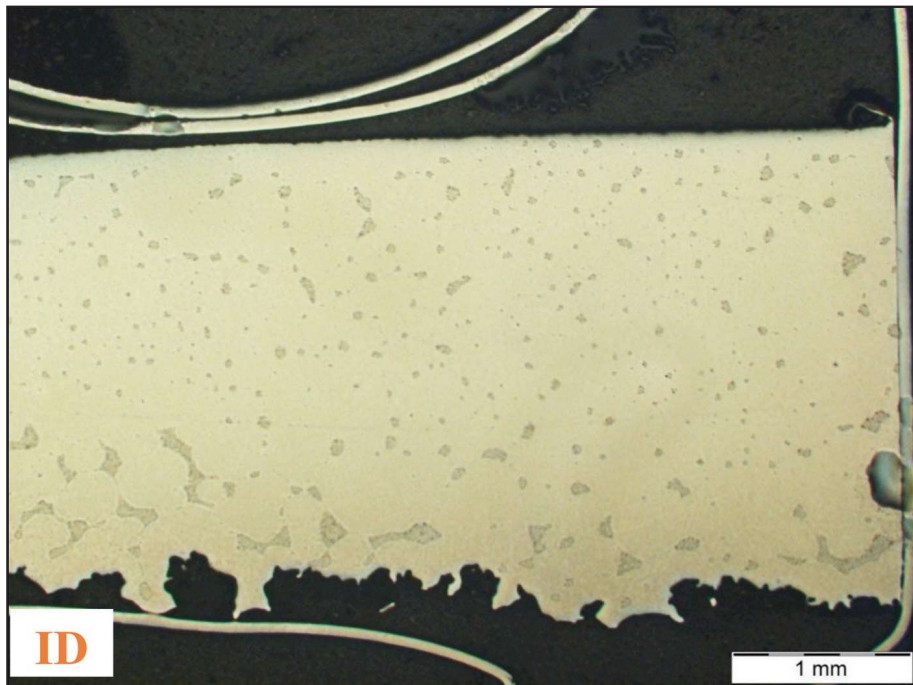
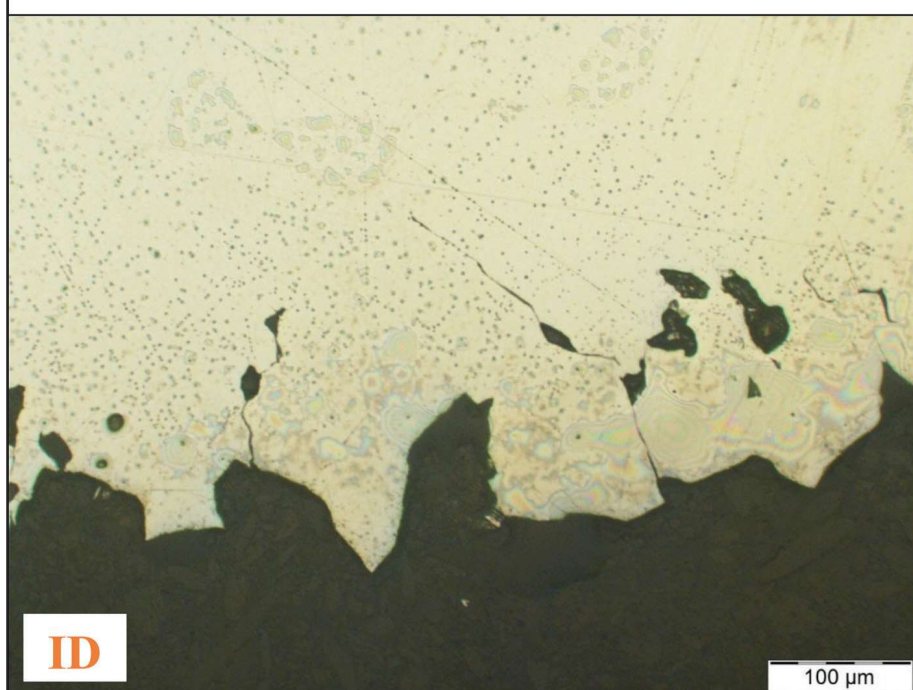
Figure 6 Photomicrographs showing the microstructure of longitudinal section of the pits and cracks initiated from the pits (un-etched, discoloration due to sample bleeding).

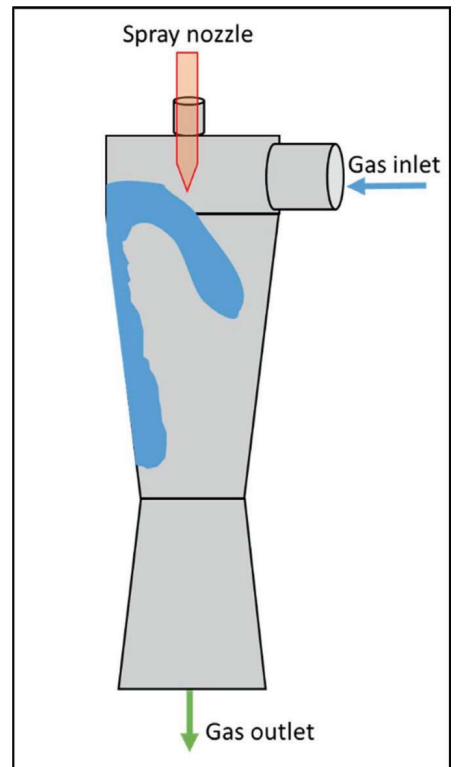
Figure 7 Illustration showing the discoloration indicating liquid patterns.
