Materials Performance Anchor Rod Questions and Responses

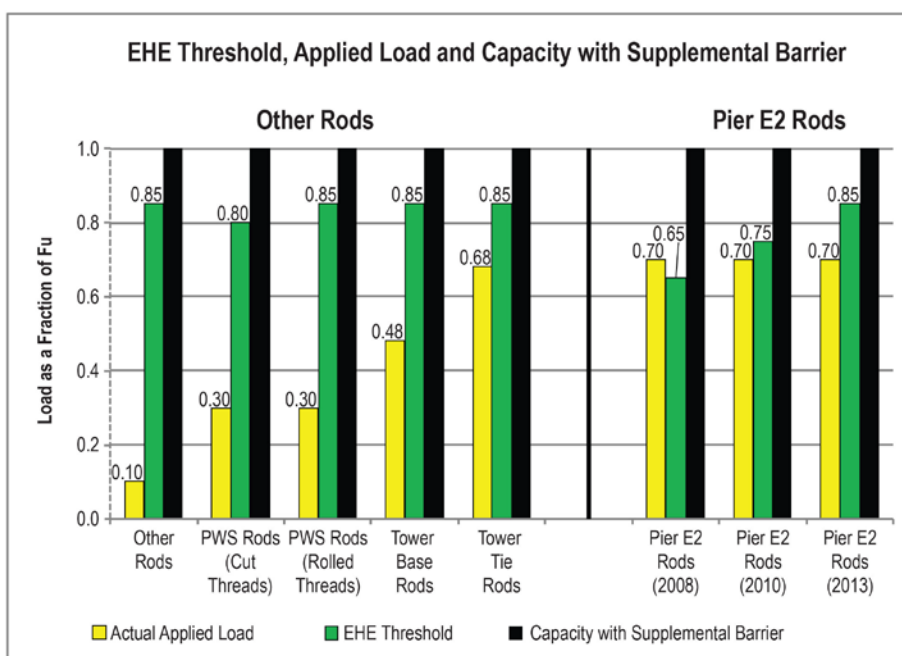
Figure 1. Summary of EHE Testing of Full-Diameter ASTM A354 BD Anchor Rods. (Note that 1.0 Fu = 140 ksi). This figure shows clearly that the service loads are less than the EHE threshold for all rods except for the 2008 rods, which failed on Pier E2. (Reference: H. E. Townsend, K. H. Frank, B. Brignano, and C. Choi, “Hydrogen Embrittlement Testing and Results of Full-Size ASTM A354 Grade BD Rods in the SFOBB,” to be published in *Bridge Structures: Assessment, Design, and Construction*, Khaled M. Mahamoud, Editor, IOS Press, Amsterdam, The Netherlands. These results are also posted online at: http://baybridgeinfo.org/sites/default/files/pdf/SFOBB-SAS%20Evaluation%20of%20the%20A354BD%20Rods%20Final%20Report_0.pdf)

In particular, the 0.48 Fu preload tension in the tower-base rods is well below the EHE threshold of 0.85 Fu as determined by our tests; it can be concluded that these rods will not fail by EHE in the near term. This conclusion is in agreement with the real-world performance of the tower-base rods, some of which have been immersed water for several years at 0.48 Fu without failure. Of course, measures are needed to remove the water and protect the rods from future exposure to water in order to prevent corrosion for the life of the bridge.

For the 2008 rods, our tests found an EHE threshold of 0.65 Fu. This result is also in agreement with the real-world behavior of the 2008 rods at the Pier E2 (shear keys S1 and S2), which failed within days of being loaded to 0.70 Fu, but did not fail when the loads were reduced to 0.45 Fu.

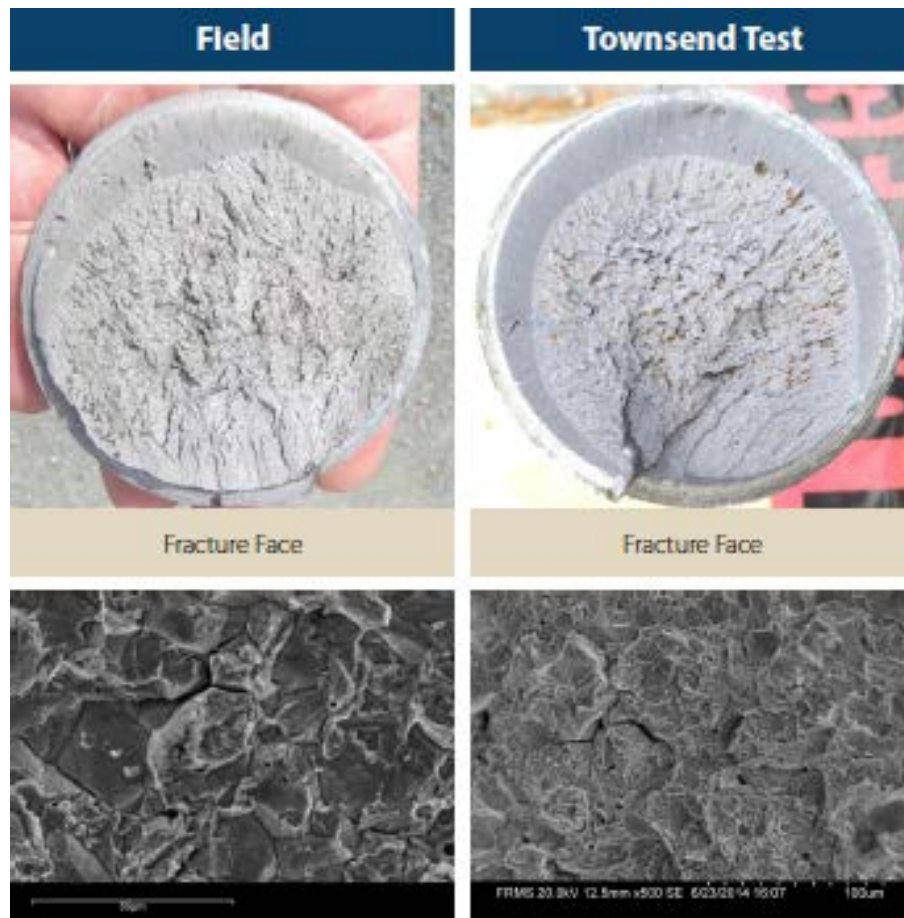
It is important also to note that our tests reproduced the macroscopic and microscopic appearance of the 2008 rod failures at E2, see Figure 2.

Figure 2. Comparison of the Fracture Surfaces of the 2008 Anchor Rods, Real-World vs. Test.

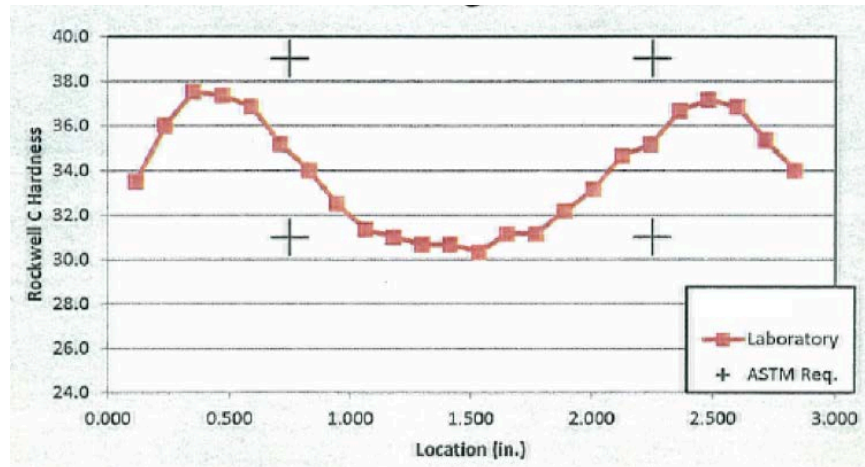
It is very significant that the EHE thresholds were found to be higher for rods exhibiting lower hardness at the outer surface. Lower surface hardness is a characteristic of rods exhibiting an M-

shaped hardness profile, as shown in Figure 3 for tower-base anchor rods. The lower surface hardness of rods with the M-shaped profile was investigated and found to be the result of lower carbon content at the outer surface.

Figure 3. M-shaped Hardness Profile, Showing lower Hardness at Outer Surfaces. This figure represents averages of laboratory and in-situ field hardness of the tower-base rods.
